**CORRELATION OF STRESS-WAVE-EMISSION
CHARACTERISTICS WITH
FRACTURE IN ALUMINUM ALLOYS**

*by C. E. Hartbower, W. G. Reuter,
C. F. Morais, and P. P. Crimmins*

Prepared by
**ADVANCED TECHNOLOGY
AEROJET SOLID PROPULSION COMPANY
Sacramento, Calif.**

NATIONAL AERONAUTICS AND SPACE ADMINISTRATION • WASHINGTON, D. C. • JULY 1972

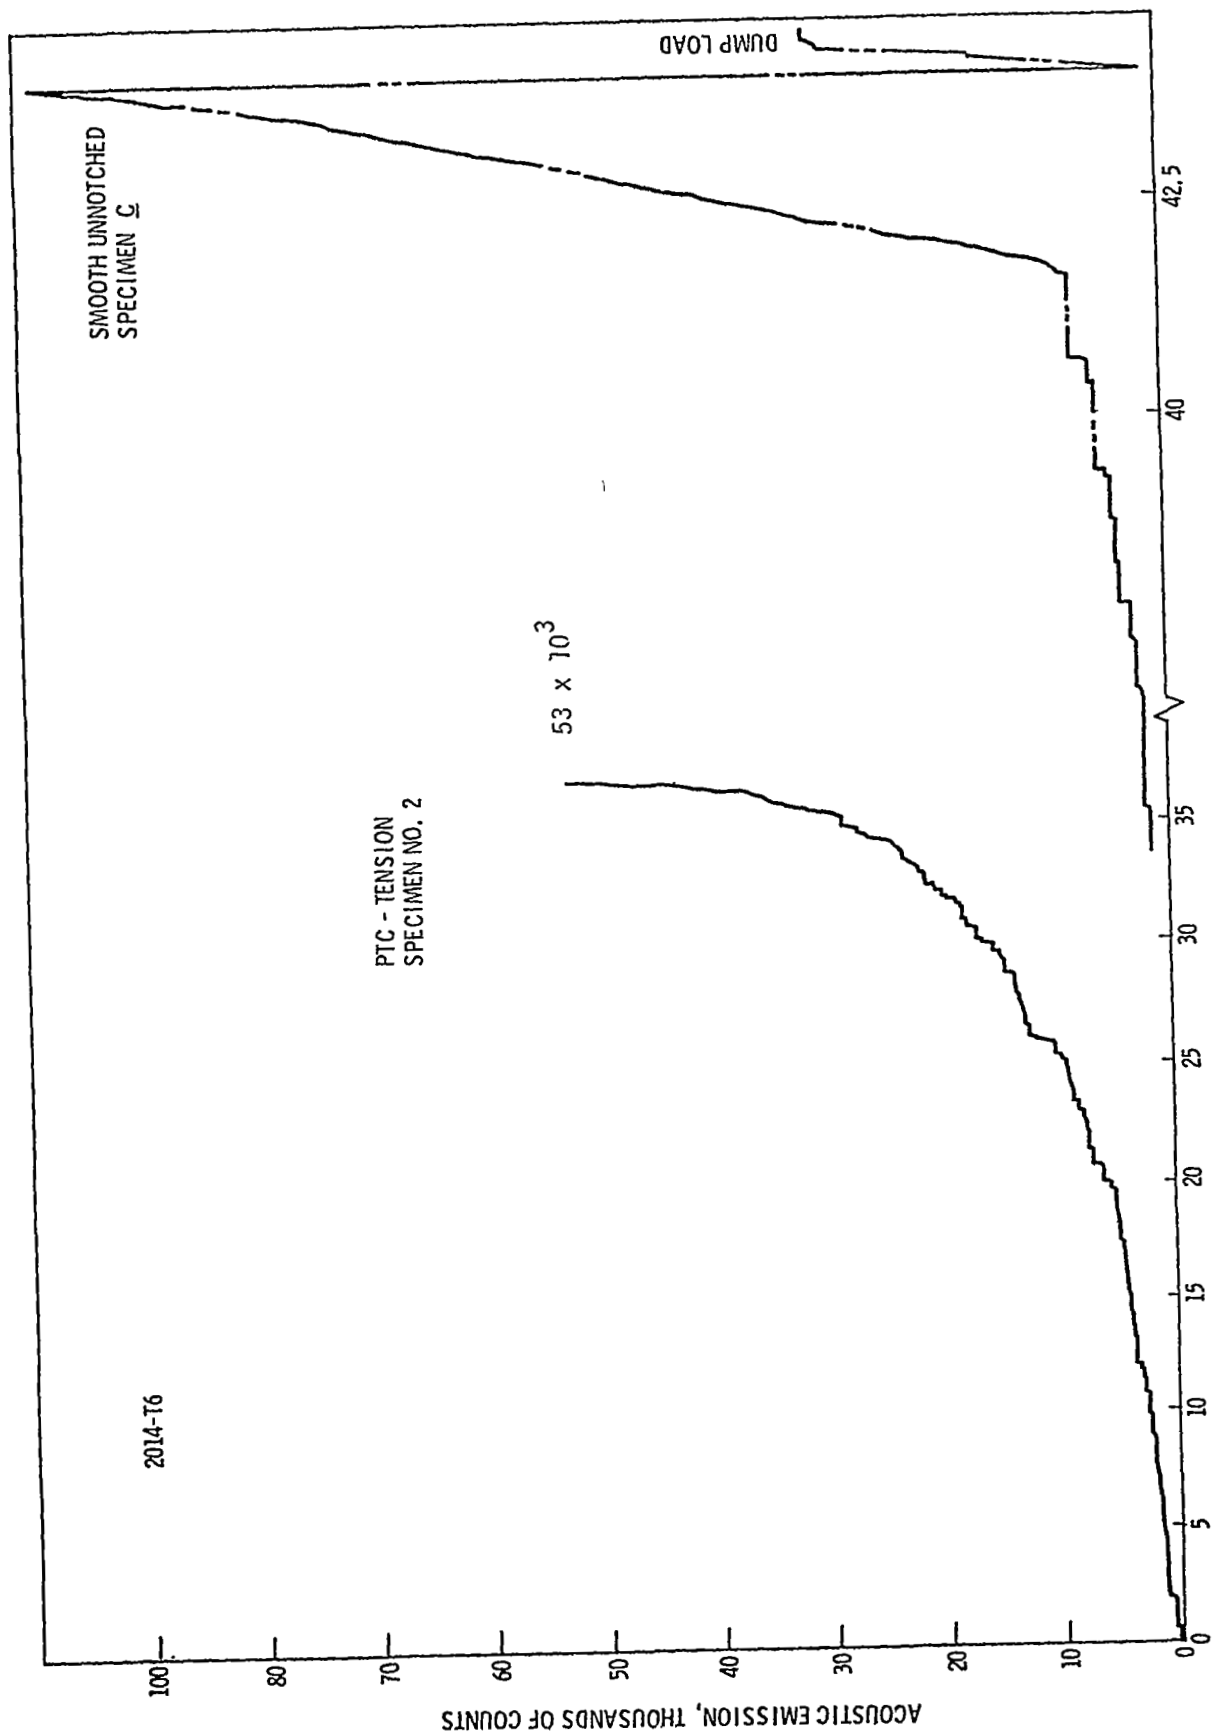
Figure 51. Comparison of Precursors in Notched (PTC) and Unnotched Tension Tests (Specimen No. 2 and C)

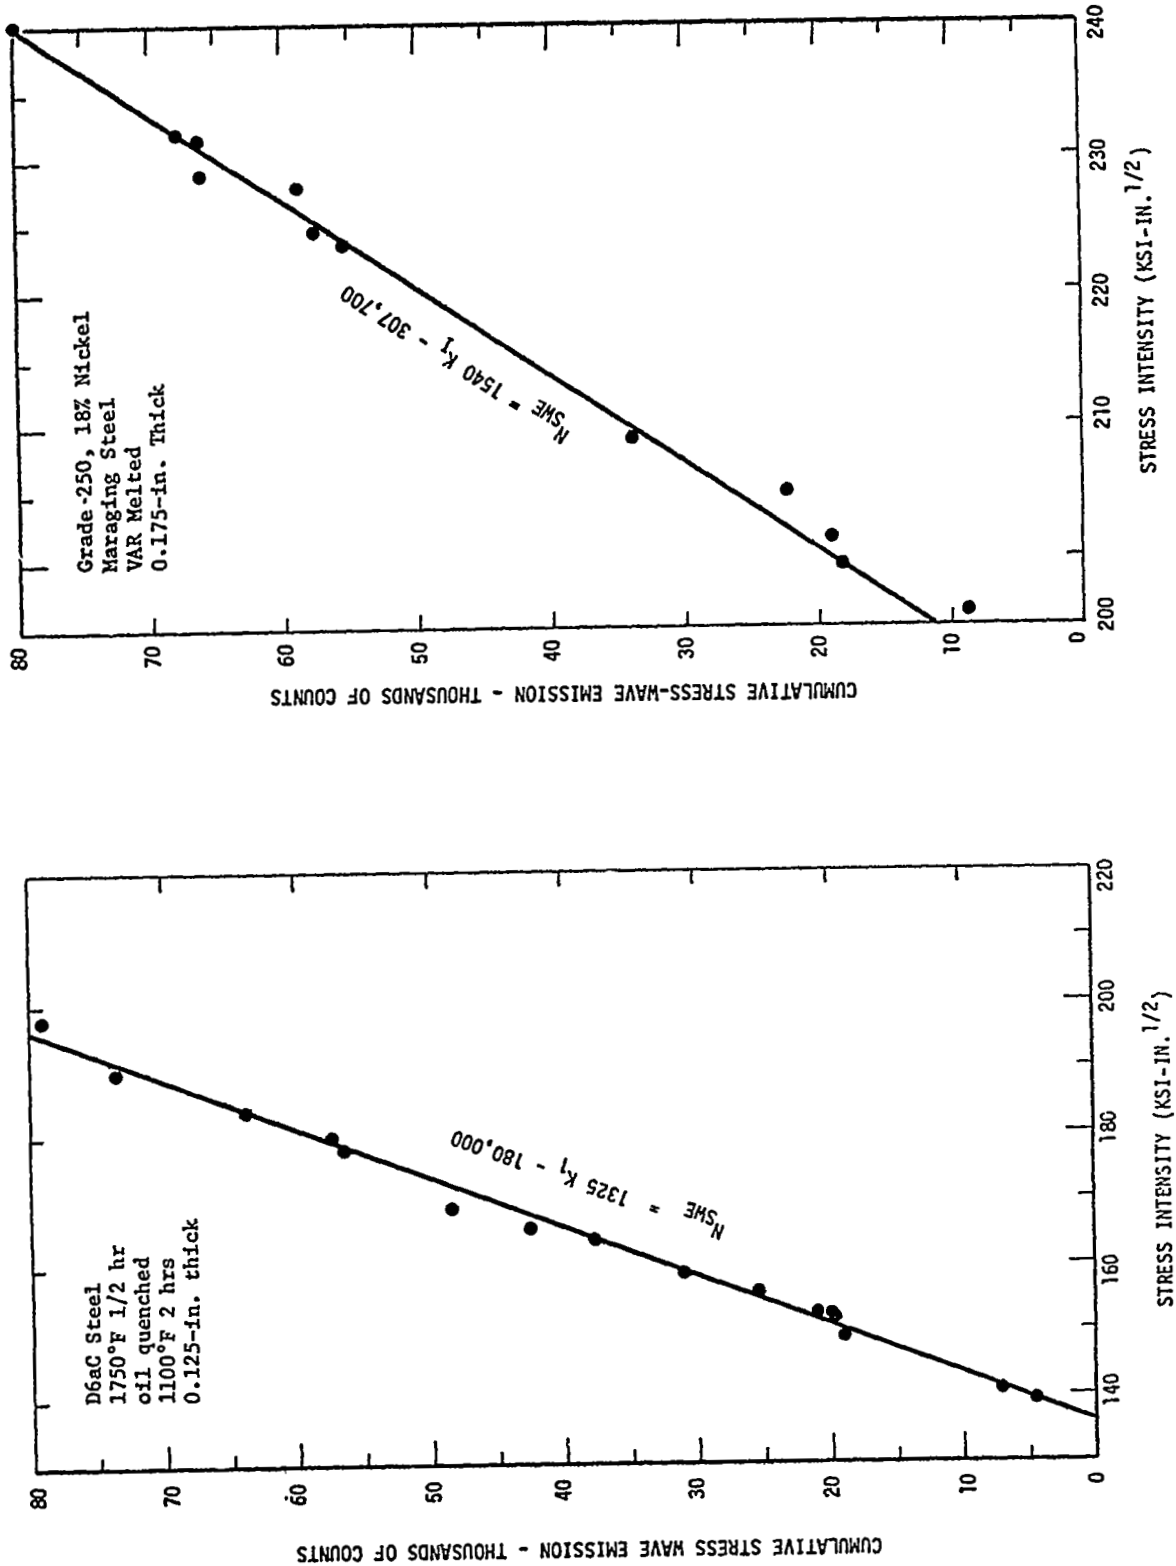
Figure 53. Relationship Between Stress Intensity and Cumulative Count for Materials Under Constant Load and Subjected to Stress-Corrosion Cracking in 70°F Water.

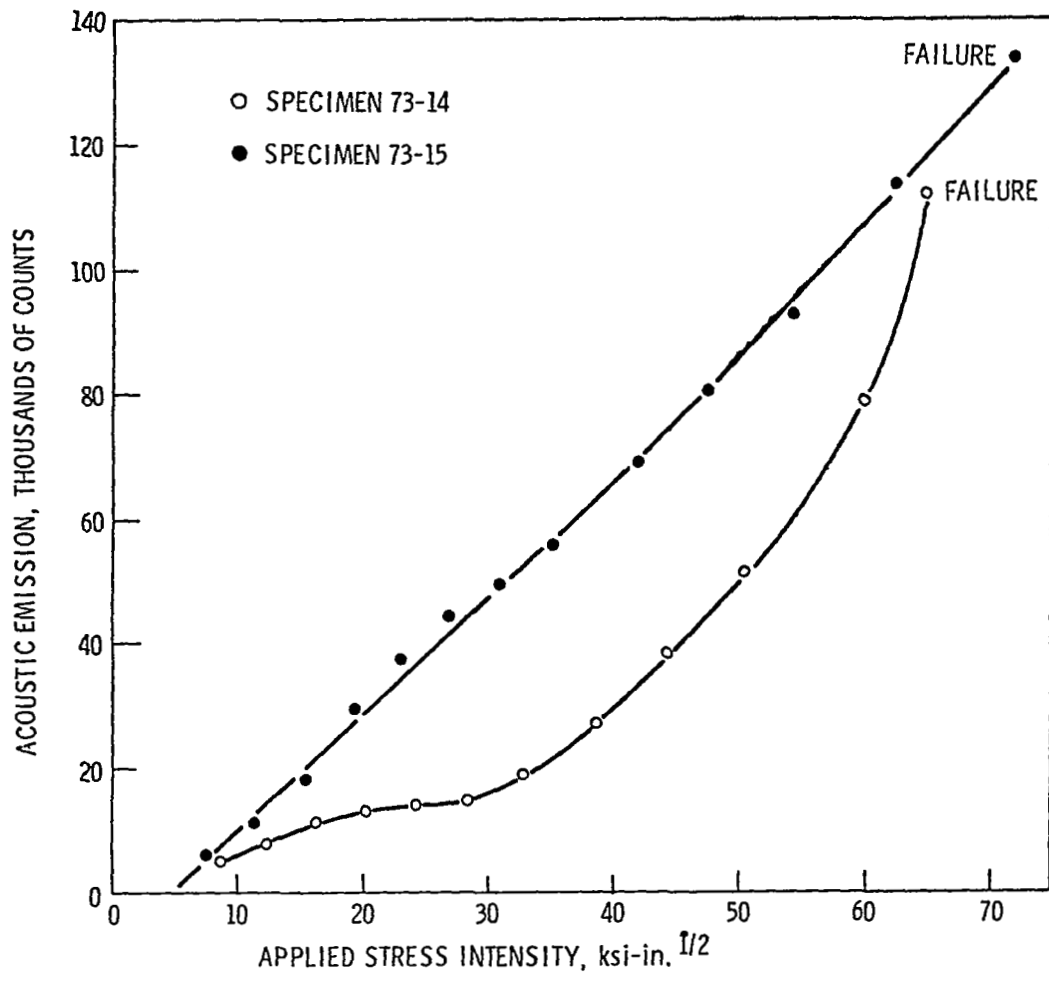
Figure 54. Relationship Between Cumulative Acoustic-Emission Count and Stress Intensity Factor in SEN-Tension Tests of 7075-T6

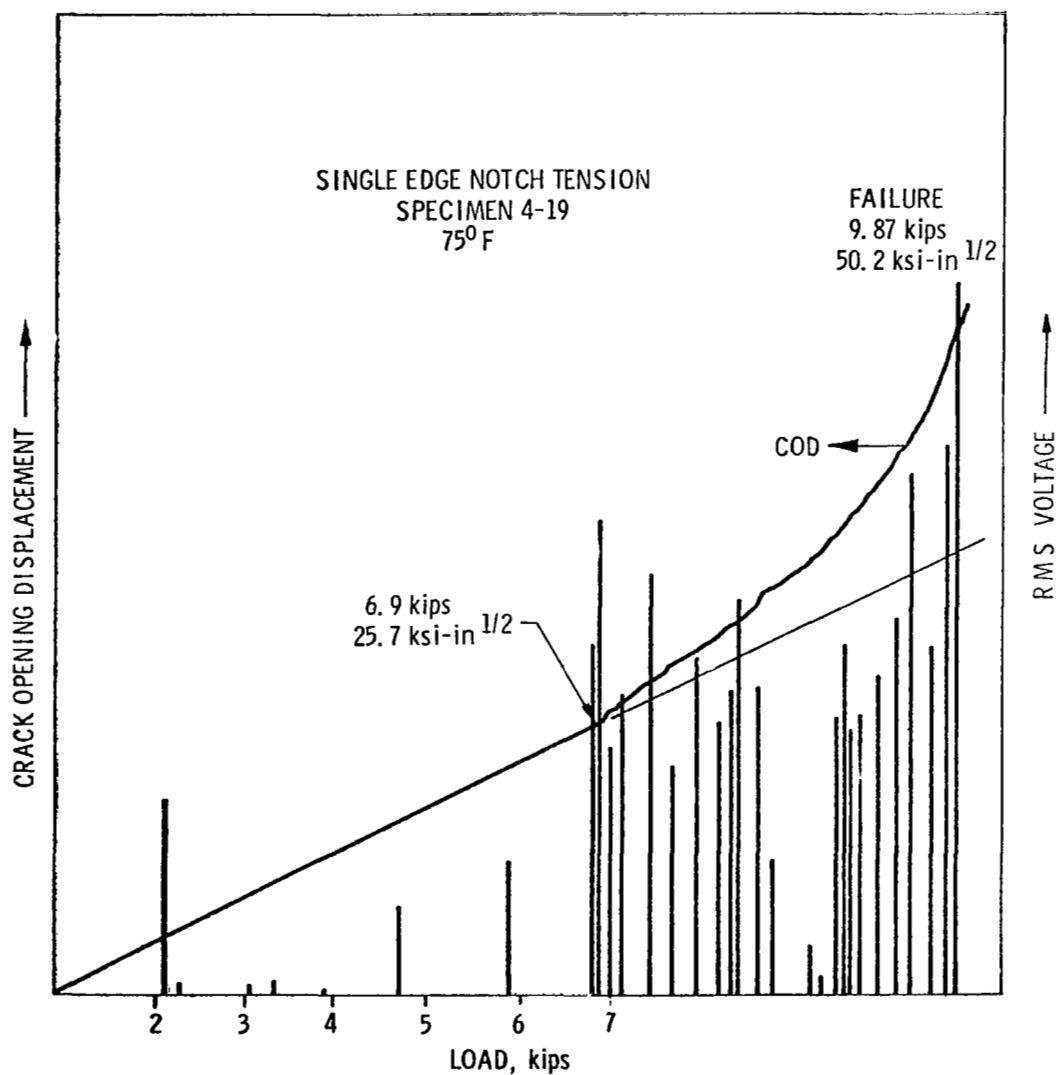
Figure 56. Correlation Between Crack-Opening-Displacement Measurement and Acoustic Emission in a SEN-Tension Test of 2014-T651 (see Table XI).

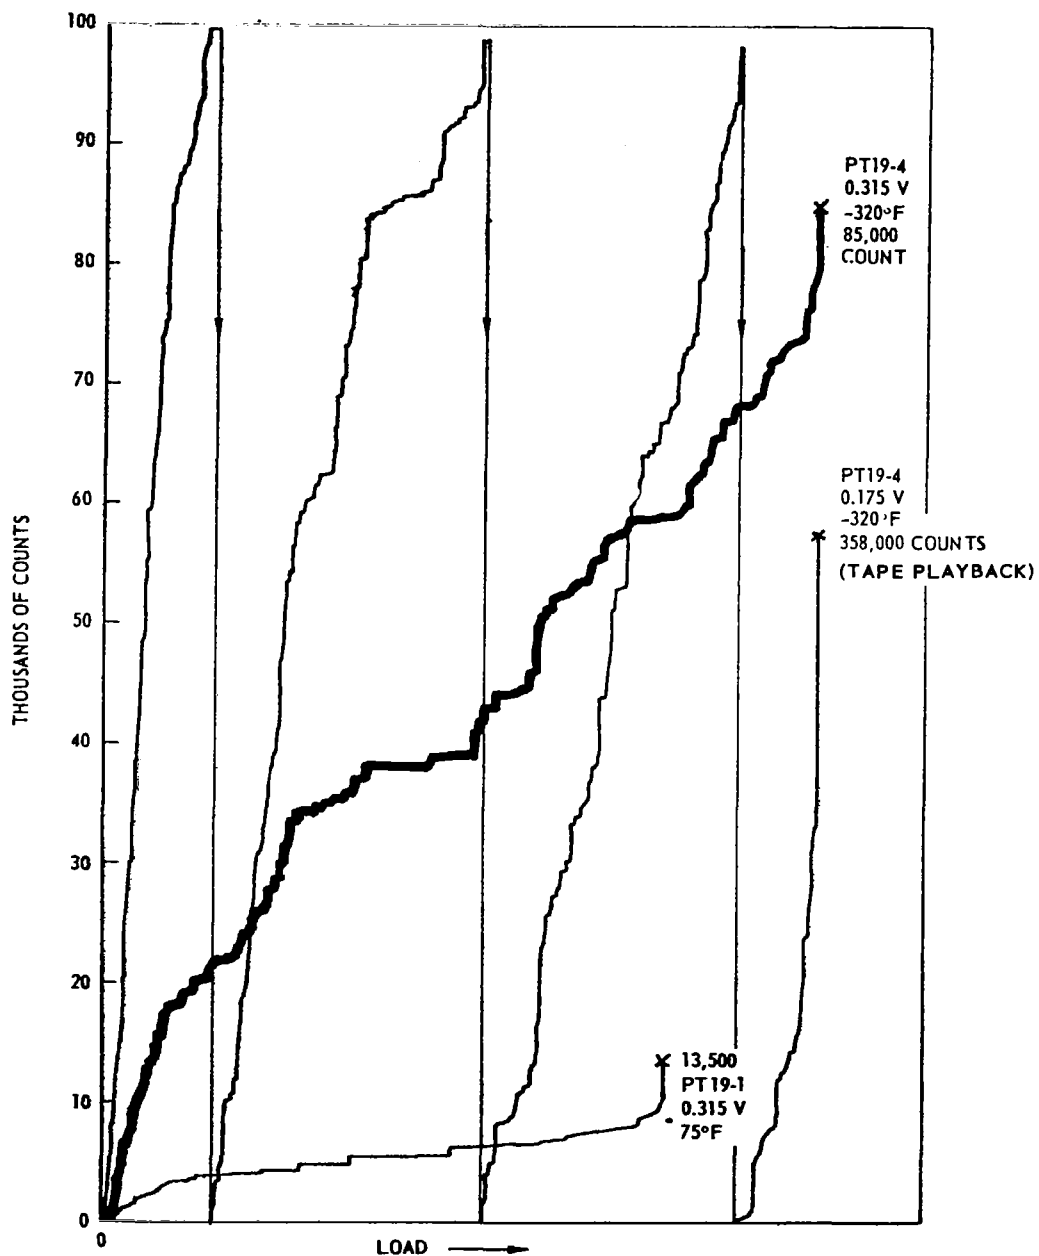
Figure 57. Effect of Temperature on SWE Count. 2014-T6 TIG Welded with 2319 Wire; Nearly Identical Flaws.

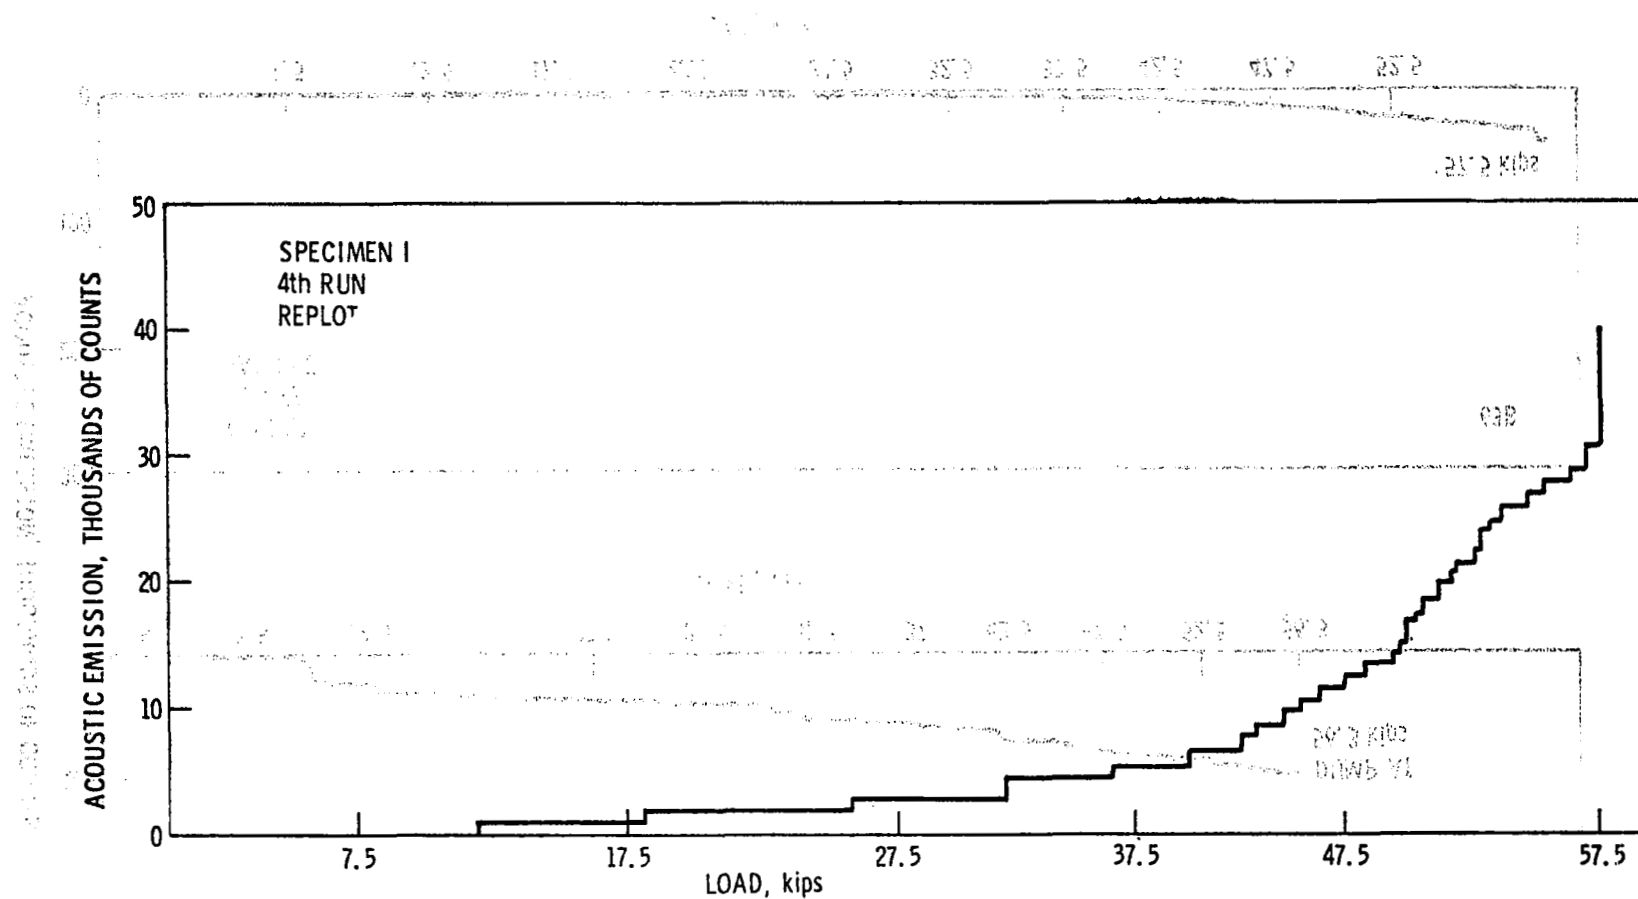
Figure 64. Effect of X-Y Plot Scale Factor on the Precursor of Failure for 2219 Specimen I at -320°F .

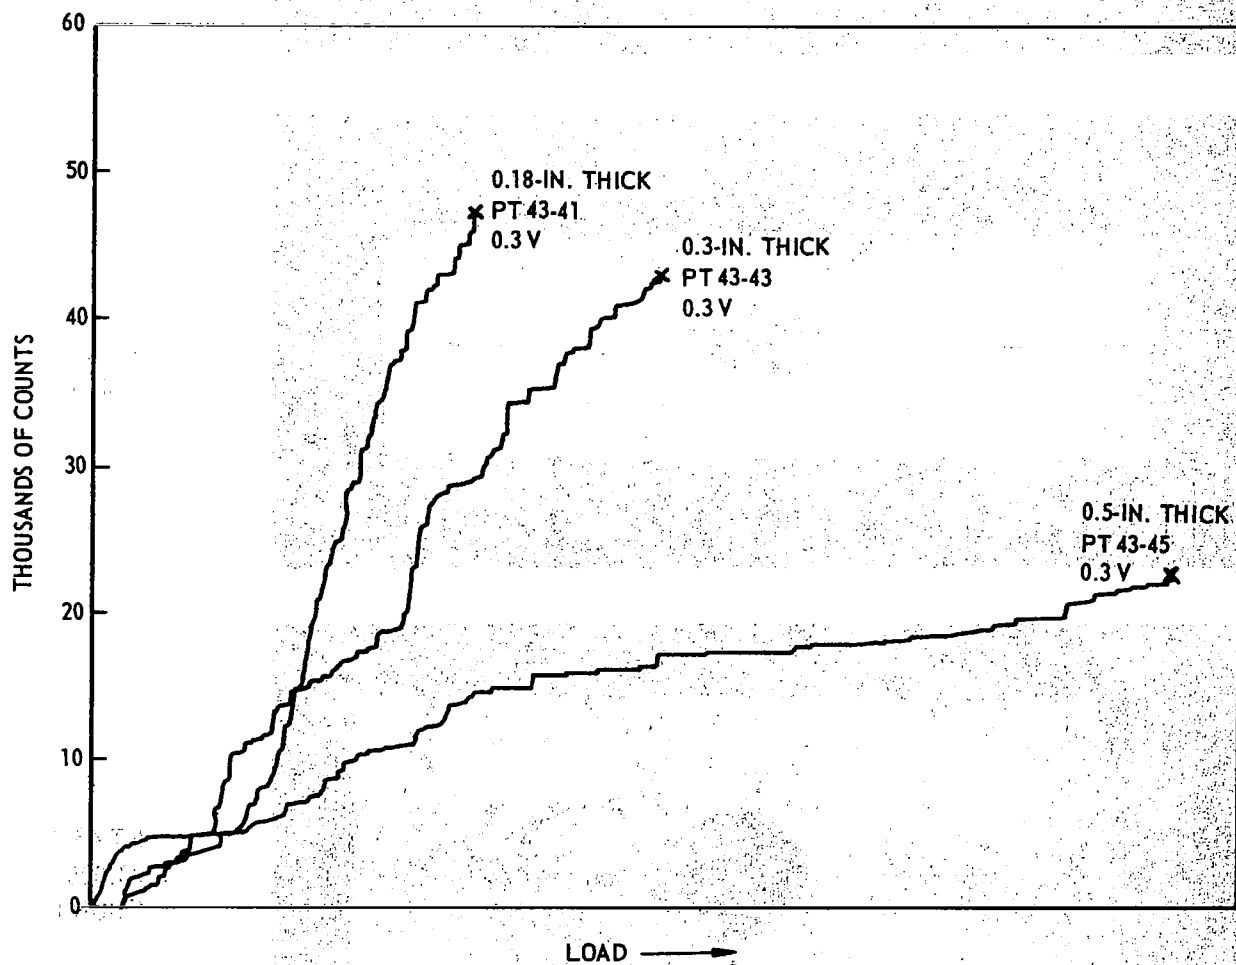
Figure 65. Effect of Specimen Thickness on SWE Count. 2014-T6 TIG
Welded with 4043 Wire; Tested at -320°F

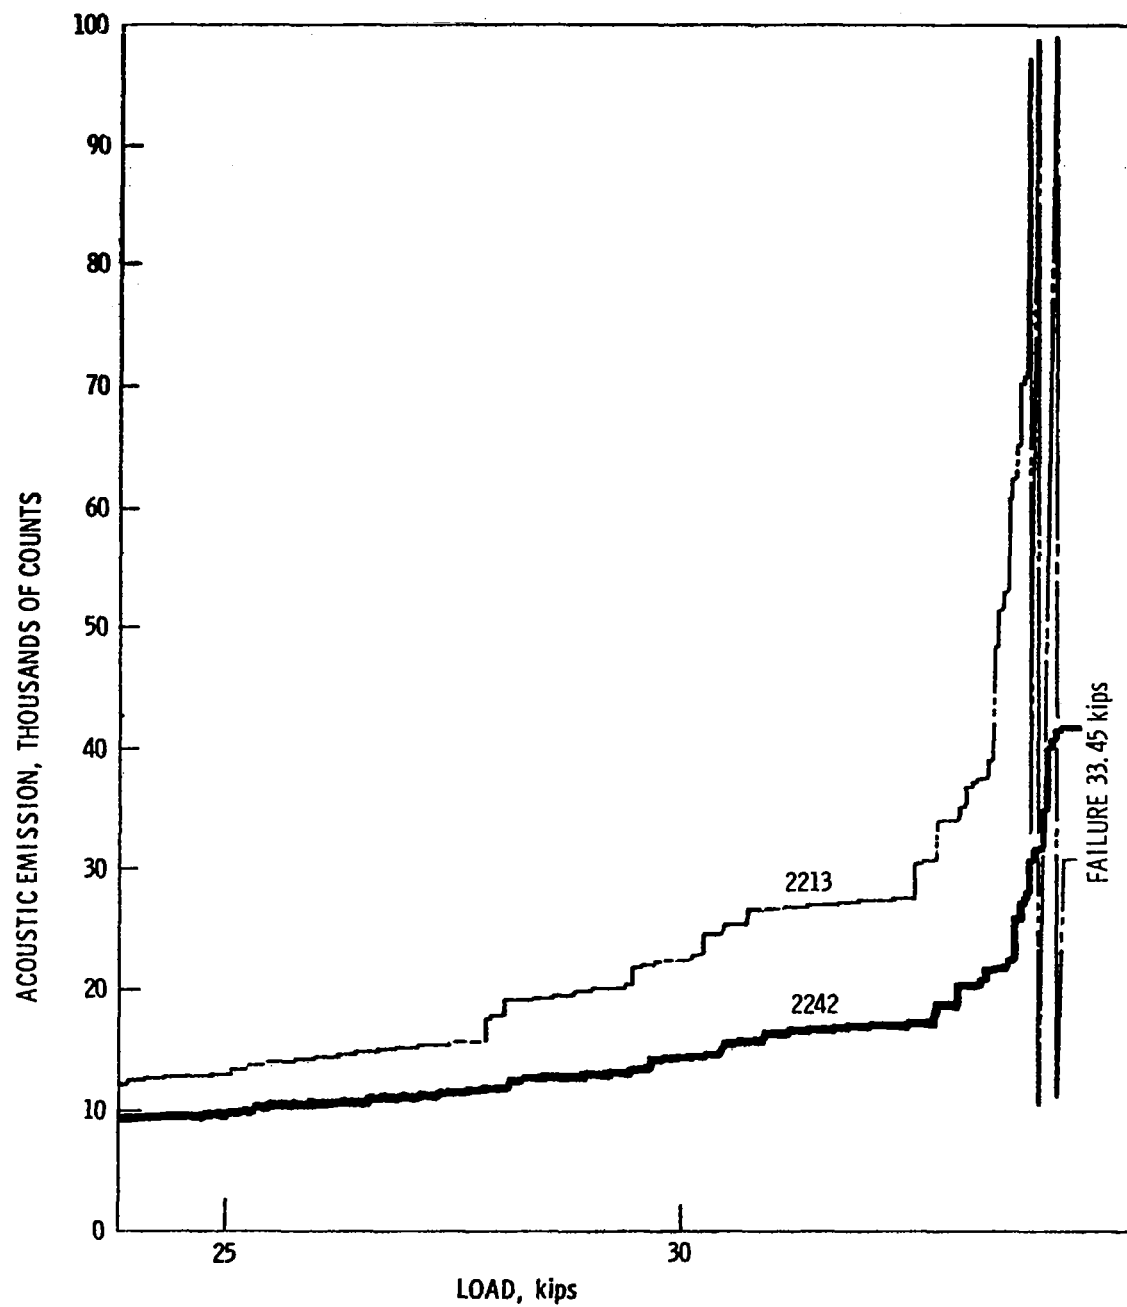
Figure 71. Comparison of Two Transducers Mounted on 2014-T6 Specimen No. 3 for the Second Cycle to Failure.

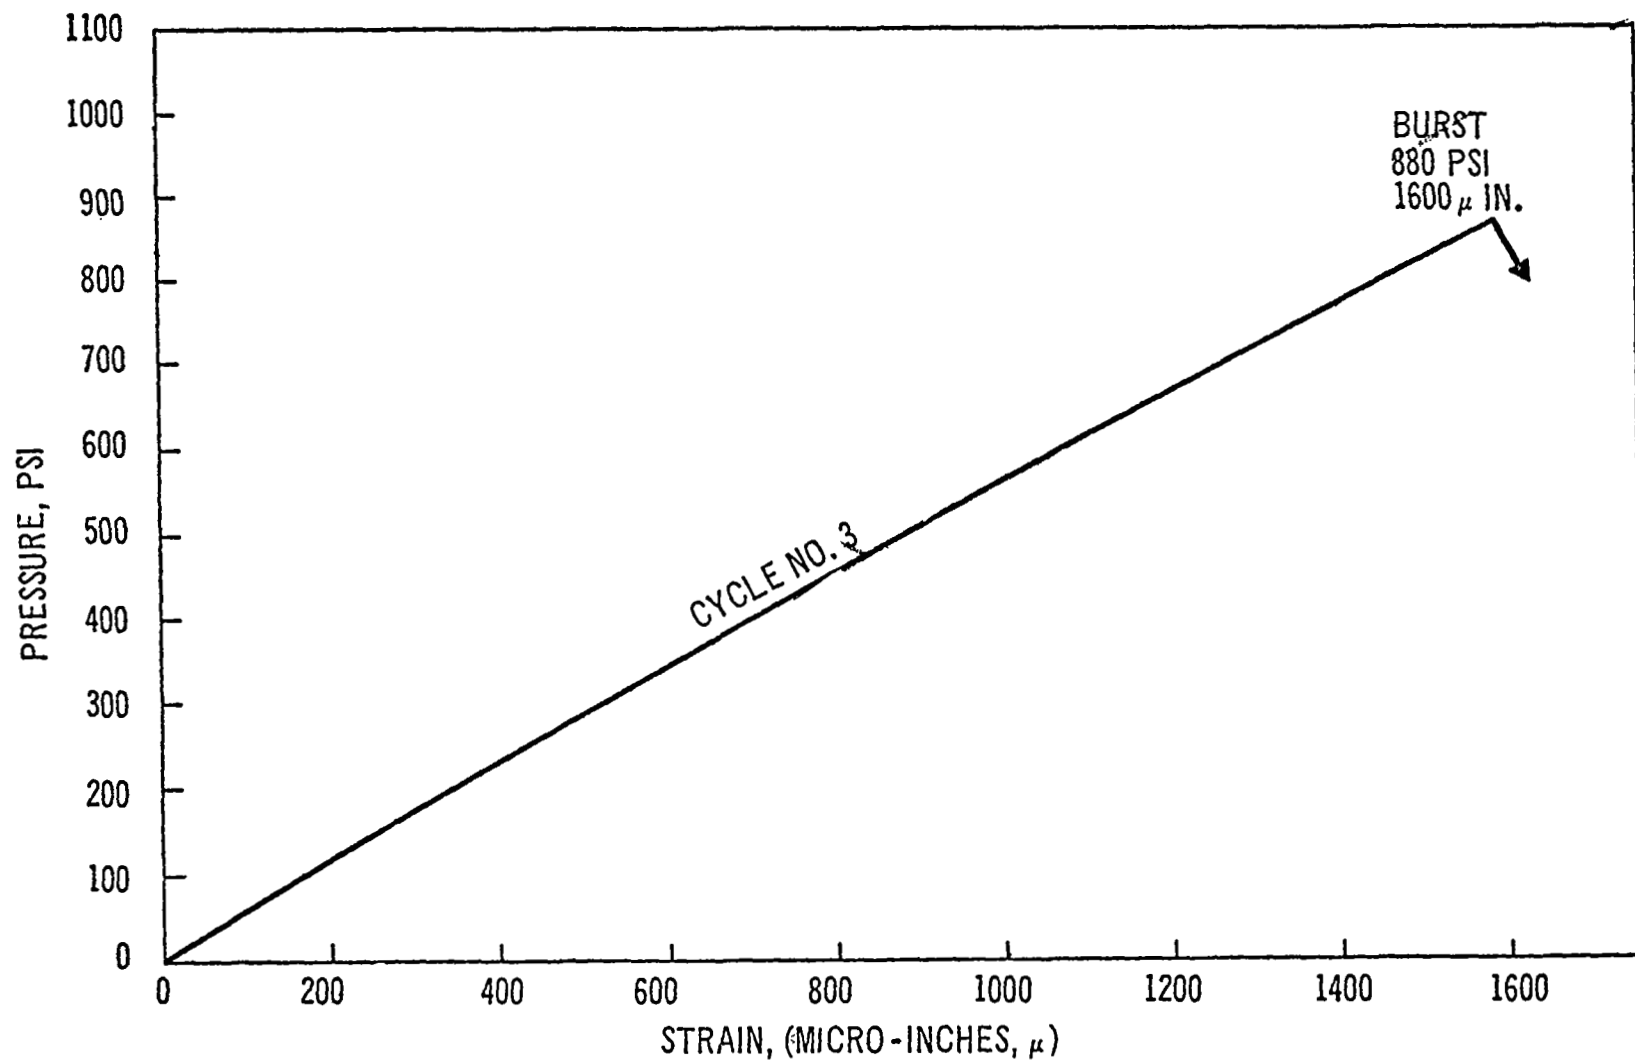
Figure 74. Strain Gage Data (Hoop Orientation) for Final Pressure Cycle of the 2014-T6 Aluminum Vessel Tested at Room Temperature. Note Elastic Behavior of the Parent Metal Cylinder Section Where the Gage was Mounted.

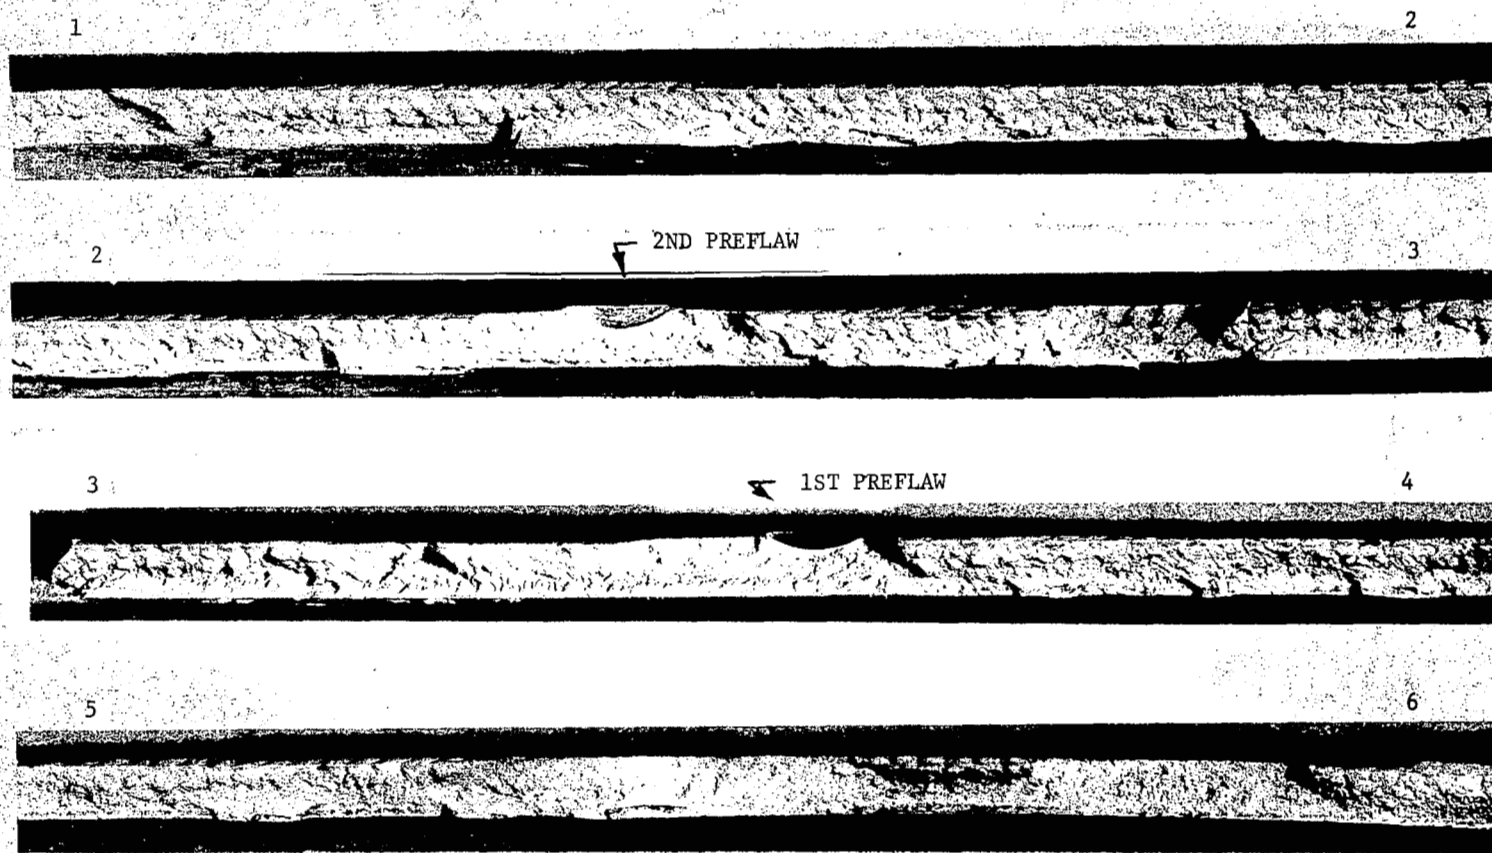
Figure 84. Longitudinal Weld Fracture Faces -2219-T87 Aluminum Vessel Hydroburst at Room Temperature. Note Preflows and Fracture Propagation Through these Defects. Failure Origin was at the 1st Preflow Introduced into the Weld. (Striations on Surface are Due to Weld Head Oscillation).

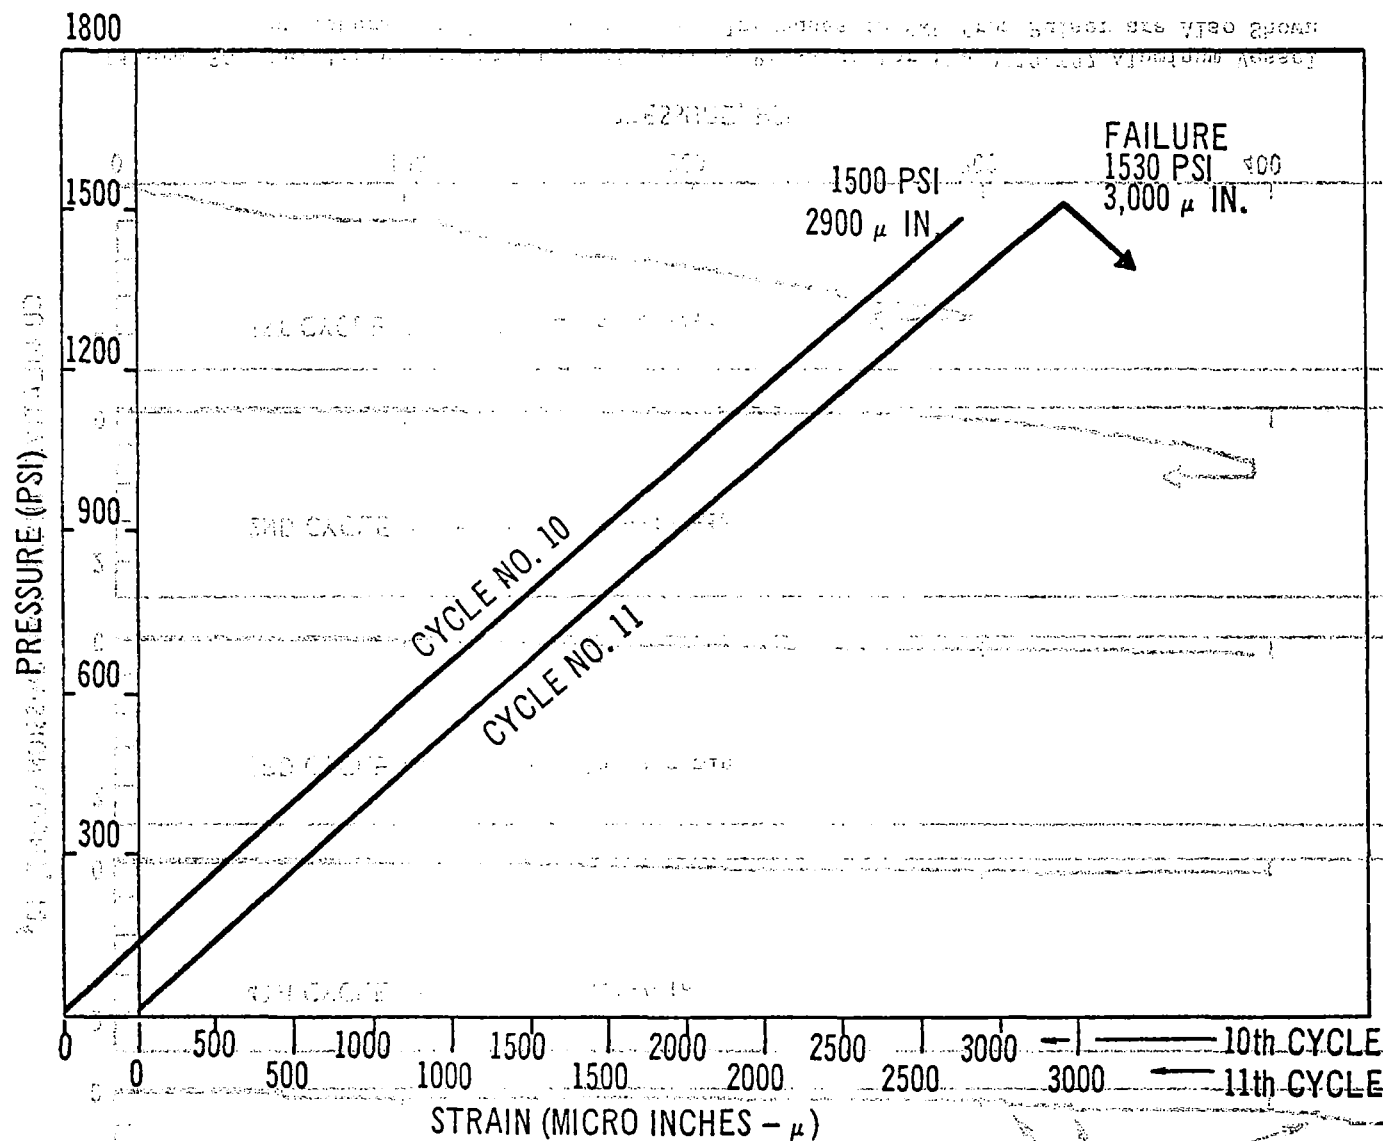
Figure 85. Strain Gage Data (Hoop Orientation) for Final Pressure Cycles of the 2219-T87 Aluminum Vessel Tested at Room Temperature. Note Elastic Behavior of the Parent Metal Cylinder Section Where the Gage was Mounted.

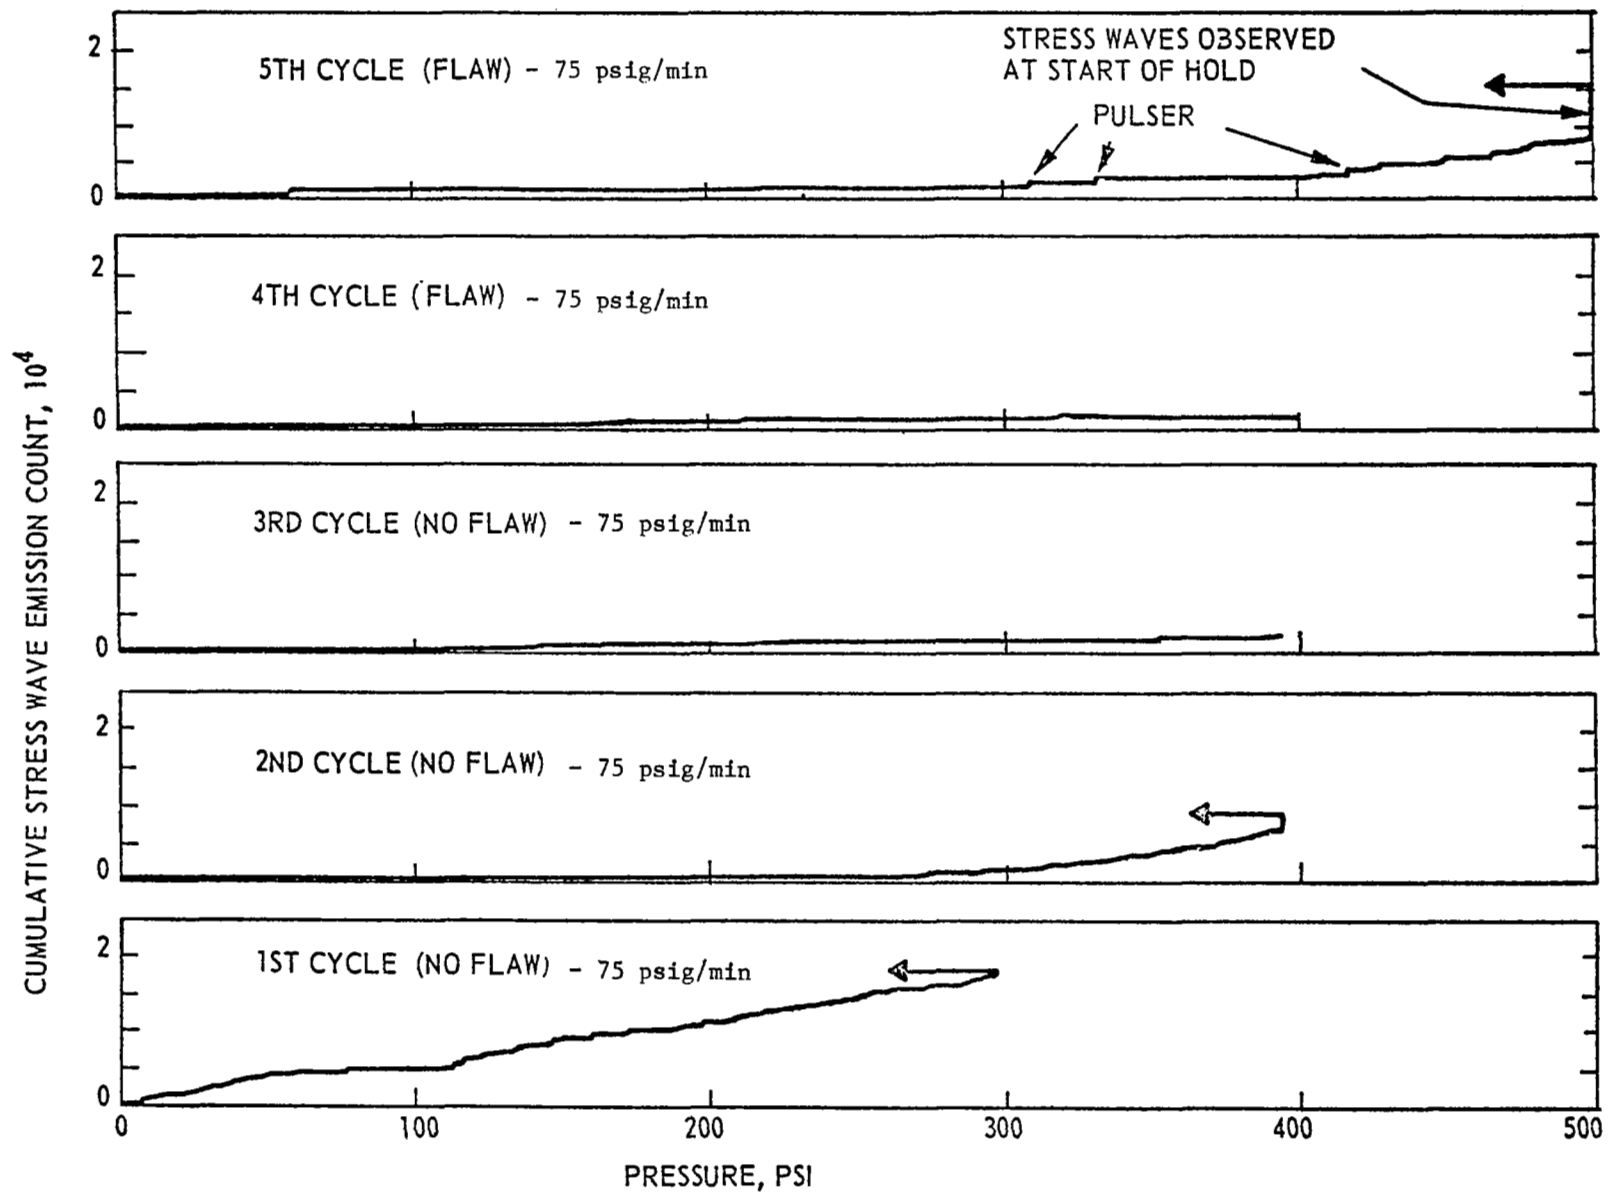
Figure 86. Cumulative Stress Wave Emission vs Pressure for the 2219-T87 Aluminum Vessel Hydroburst at Room Temperature. Increases in SWE from Pulser are Also Shown

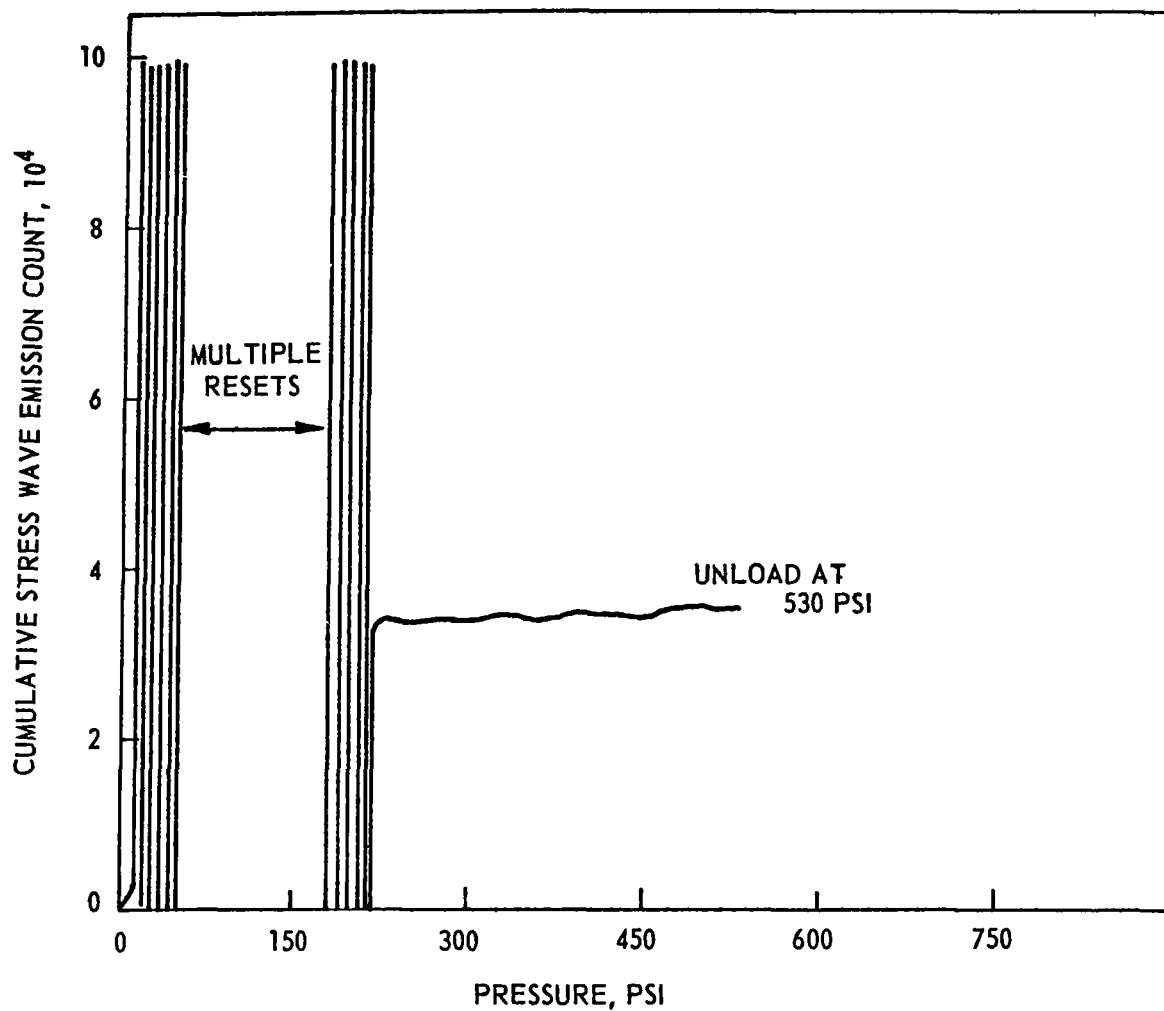
Figure 99. Cumulative Stress Wave Emission vs Pressure for the 2014-T6 Vessel Tested at -320°F . Cycle No. 1 of a Two Cycle Test Series (Page 1 of 2)

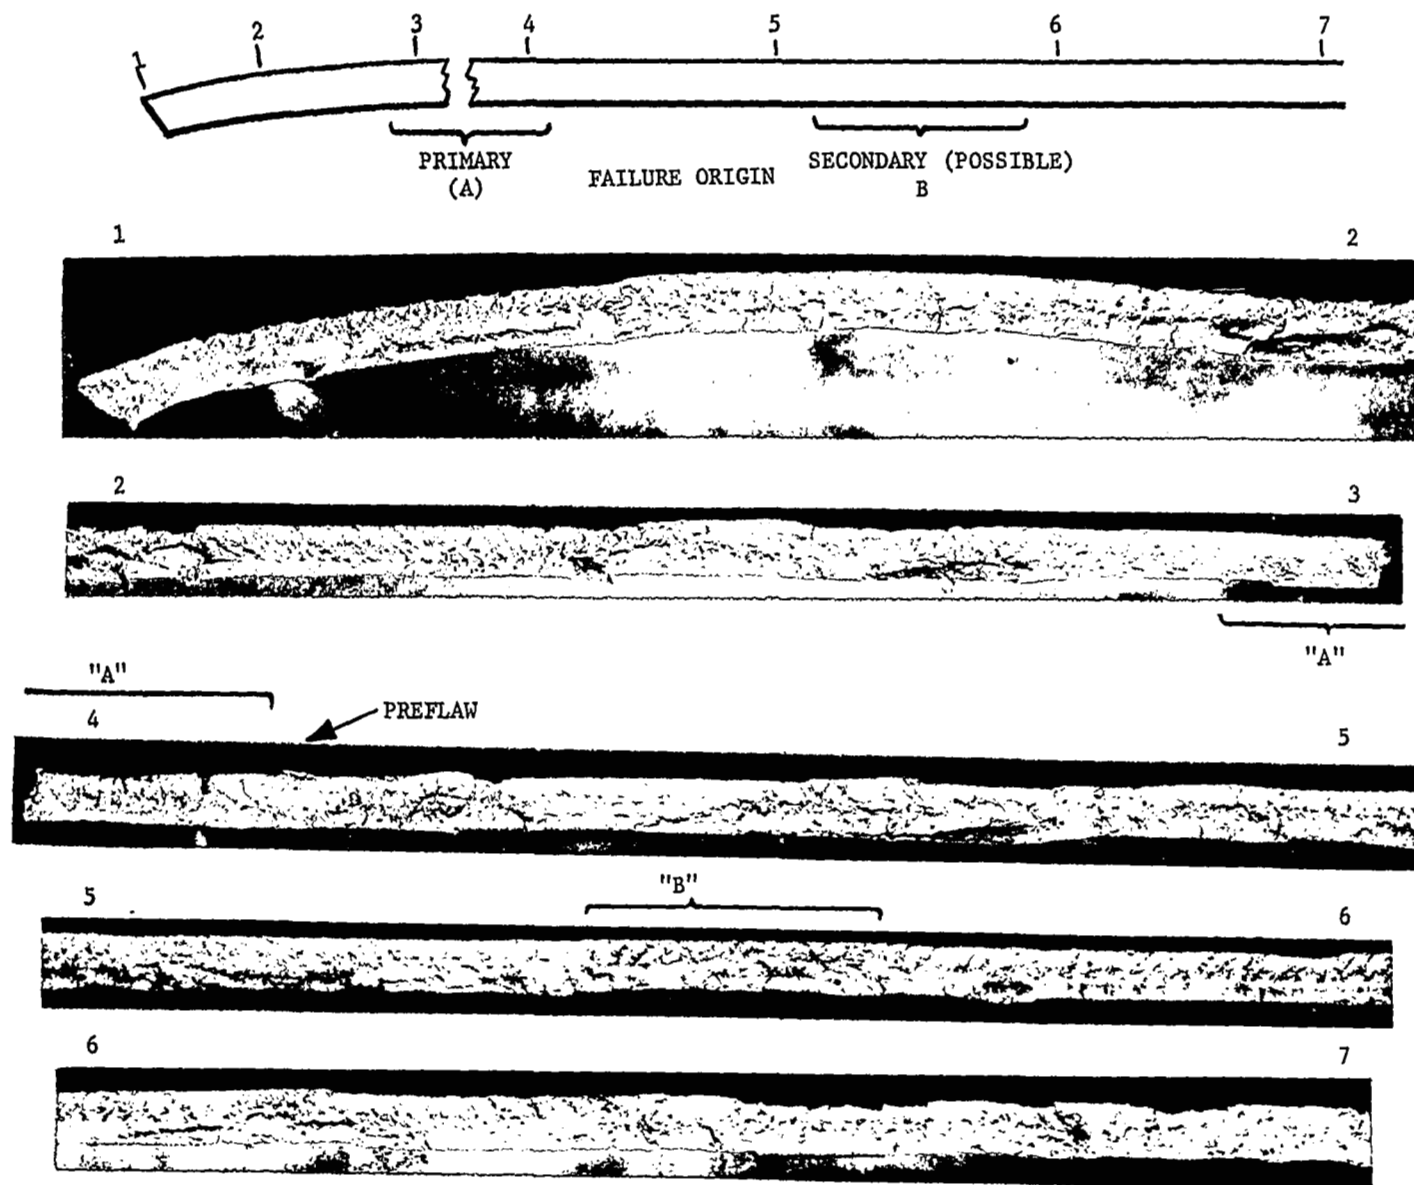
Figure 102. Longitudinal Weld Fracture Faces -2014-T6 Aluminum Vessel Hydroburst at -320°F .
 Note Preflaw (arrow) and that the Fracture Did Not Propagate Through
 This Defect. (Striations on Surface are Due to Welding Head Oscillation)

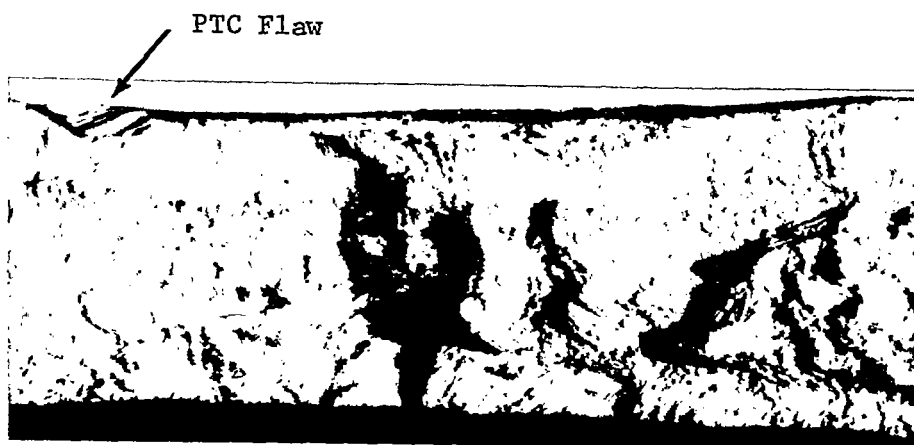
Figure 103. Areas of Longitudinal Weld Non-Fusion, Inclusions and Porosity on the Fracture Surface of the 2014-T6 Aluminum Vessel Burst at -320°F . Figure 102 shows the location area "A" of these defects in the longitudinal weld. Note - the end of the PTC flaw in (3) and that the fracture surface did not propagate through this defect. (Magnification approximately 4X)

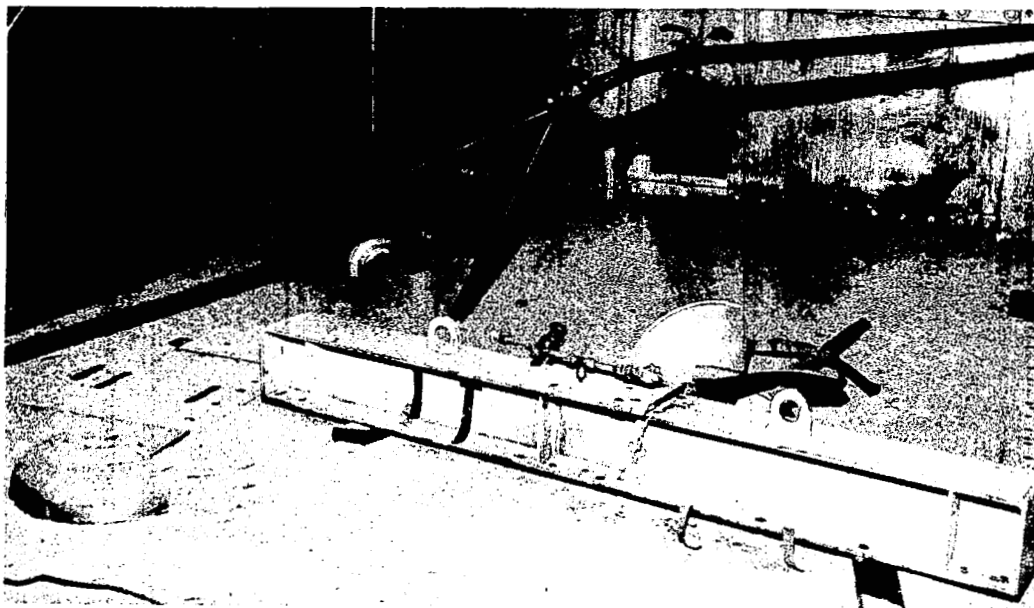
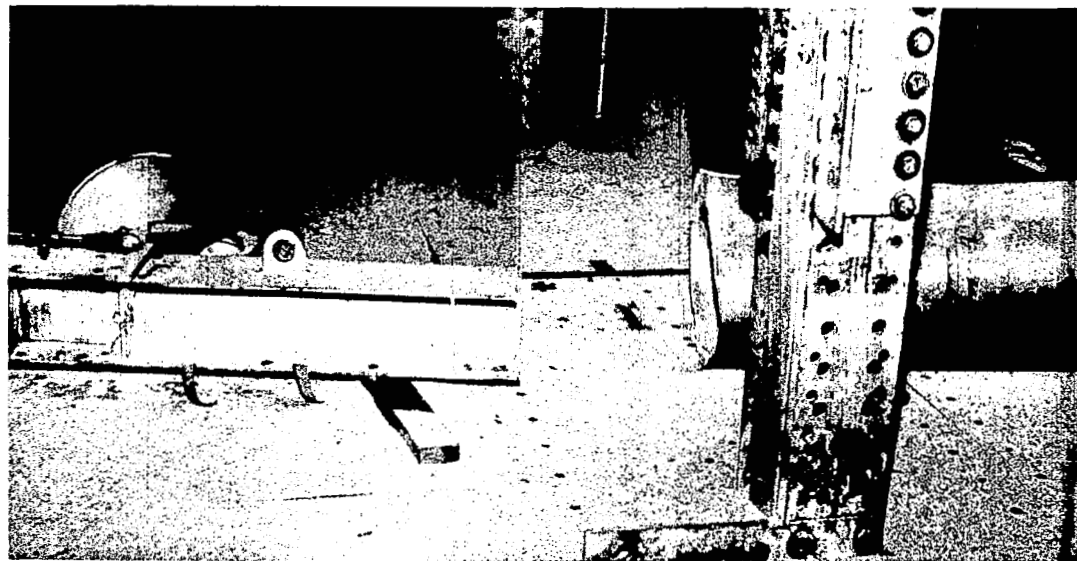
Figure 105. Fractured 2219-T87 Aluminum Chamber in Test Cell After Testing at -320°F .
